Livingstone Range School Division No.68

10-Year Planning Priorities (2016-2026)

3-Year Capital Plan (2017-2020)

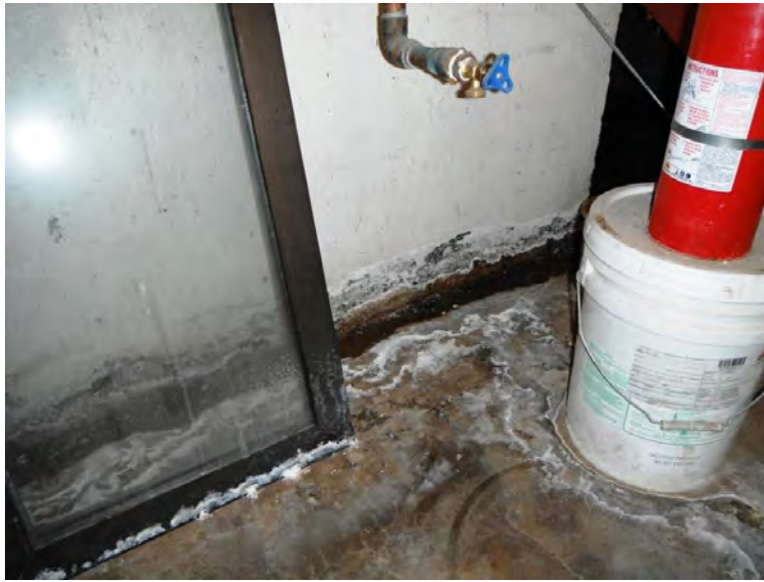
The mechanical room floor was wet in most areas, and moisture had wicked up the walls in the room. Crystalline deposits consistent with the precipitation of salts were observed on the floor. Trace crystalline deposits were also observed on the lower portion of the walls.

The deposits are consistent with groundwater moisture infiltration, carrying water soluble salts through concrete where they precipitate and accumulate within the building.

Photo 1: Crystalline salt deposits on floor slab and lower portion of walls

Based on the site observations and results of the laboratory testing and analysis, the primary mode of failure is trace concrete delamination and paint loss. This mode of failure can be attributed to a form of physical sulphate attack.

Two forms of sulphate attack are commonly seen. The first form of sulphate attack is physical, which has caused some concrete delamination in the lower portion of the walls, and the formation of crystalline sulphate minerals. The mechanism for deterioration of this physical sulphate attack is volume expansion of precipitating sulphates within the concrete, which imposes tensile forces within the concrete. As moisture infiltrates the concrete

The sulphate attack observed in the mechanical room of the JT Foster School is considered minor at this time; however, the potential for further sulphate attack in both chemical and physical forms exists. The school was constructed in the 1960s and therefore the rate of concrete deterioration is considered slow and there is no evidence that the structural integrity of the walls is compromised.

Any rehabilitation of the interior surface of the walls will not stop the sulphate accumulation, as the sulphate is being introduced externally, but may increase the service life of the walls. Measures to lower the water table may not be practical but a membrane application on both sides of the affected walls would slow down the sulphate bearing moisture ingress to the walls. Since the concrete condition in the cores was good, the repairs are feasible; however, the logistics of placing a membrane on the outside of the mechanical room walls is not known.

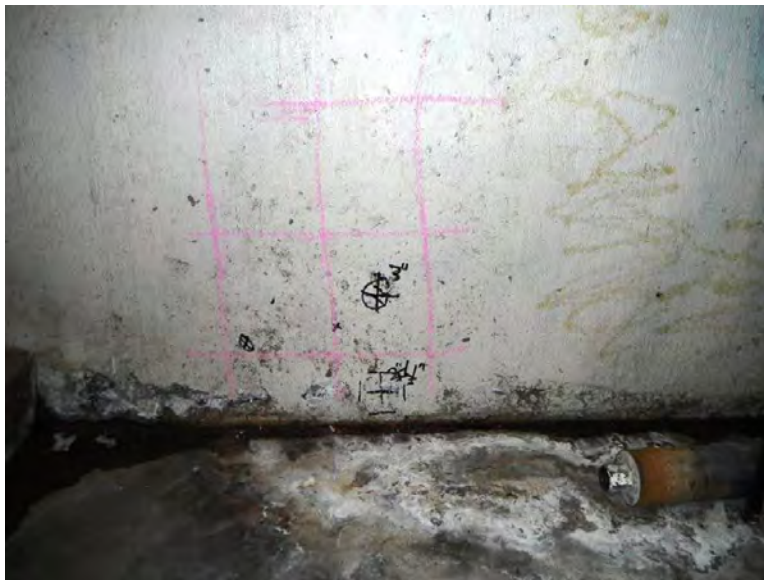
Photo 2: Crystalline salt deposits on floor slab and lower portion of walls

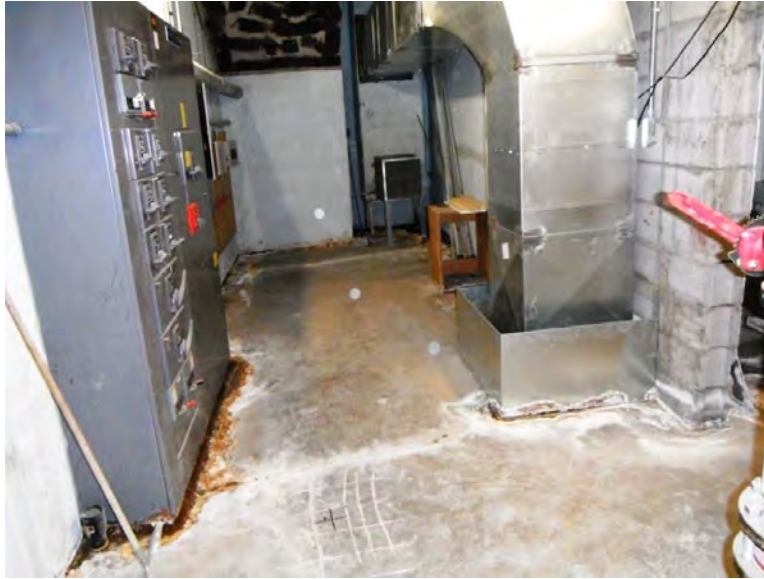
Photo 3: Crystalline salt deposits on floor slab and lower portion of walls and mechanical equipment

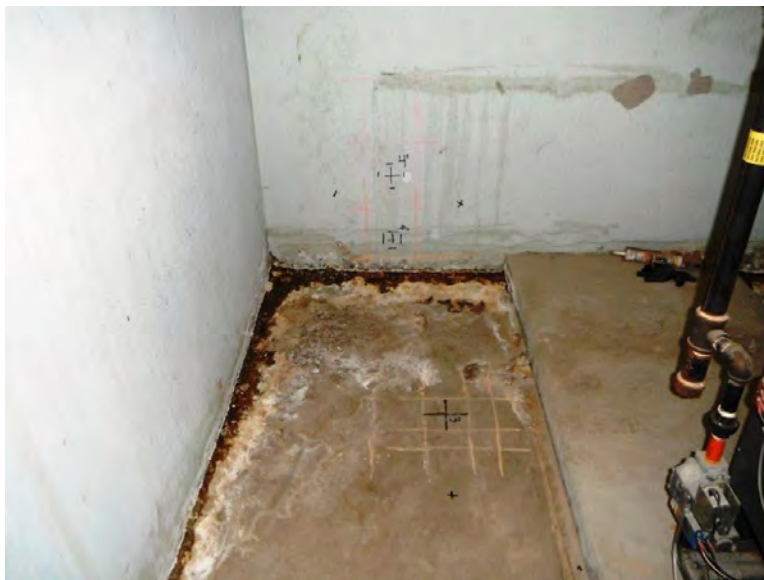
Photo 3: Crystalline salt deposits on floor slab and lower portion of walls

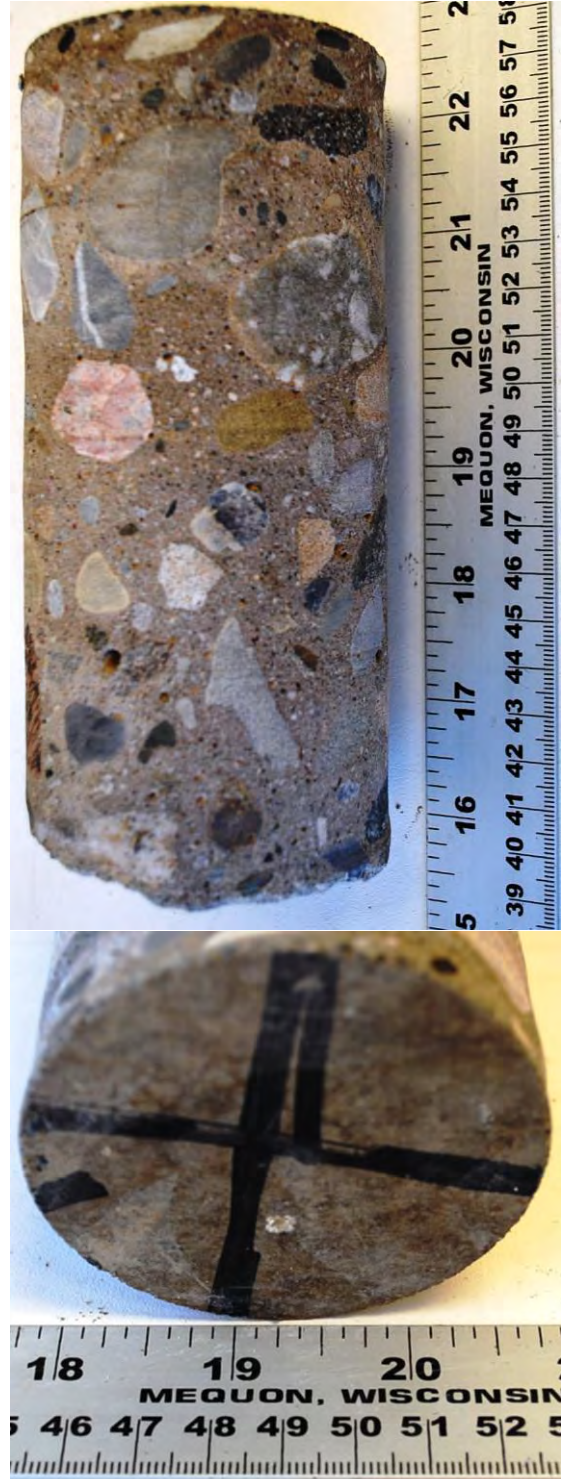
Aggregate	Aggregate Maximum Size:	40 mm
	Aggregate Shape:	Subrounded with trace fractured faces
	Composition:	Predominantly carbonate and quartzite with traces of sandstone and ironstone
	Gradation/Proportion:	Well graded, approximately 60% to 70% by volume
	Other:	
Concrete/Paste	Degree of Consolidation:	Well consolidated
	Condition of Cement Paste:	Competent
	Entrained Air:	Non air-entrained
	Bleeding Voids:	Good
	Aggregate/Paste Bond:	None identified
	Alkali Silica Reaction:	No chemical attack identified; trace sulphate
	Sulphate Attack:	precipitates observed
		None identified
	Freeze/Thaw Damage:	None identified
	Cracking/Fractures:	None identified
	Carbonation:	Carbonated to depth of 50 mm
	Other:	Slab placed on poly moisture barrier
Surface	Surface Condition:	Competent
	Finishing:	Steel trowel smooth finish
	Other:	
Reinforcement	Location:	None in core
	Size:	
	Reinforcement Condition:	
	Other:	
General		Overall competent concrete but may have the potential for sulphate attack.

Concrete is not consistent with that seen in the walls
	Additional Tests:	SSD Density - 2353 kg/m ³
		Compressive Strength - 23.6 MPa
		Water Soluble Sulphate Content - 0.23%

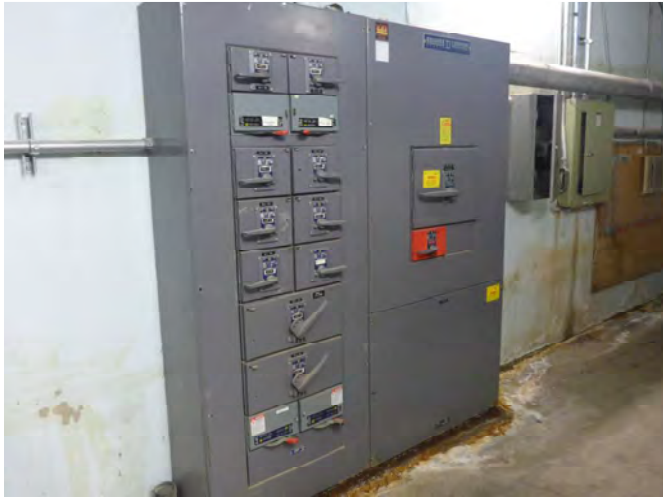
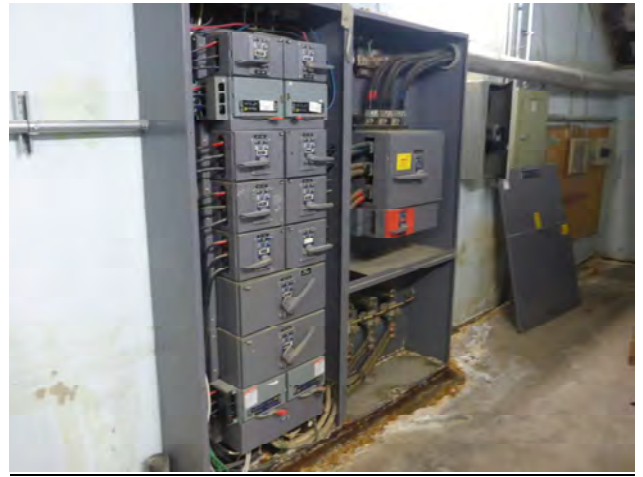
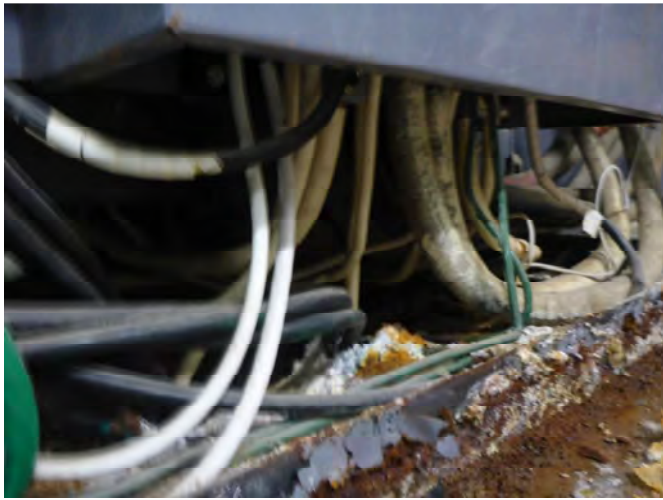
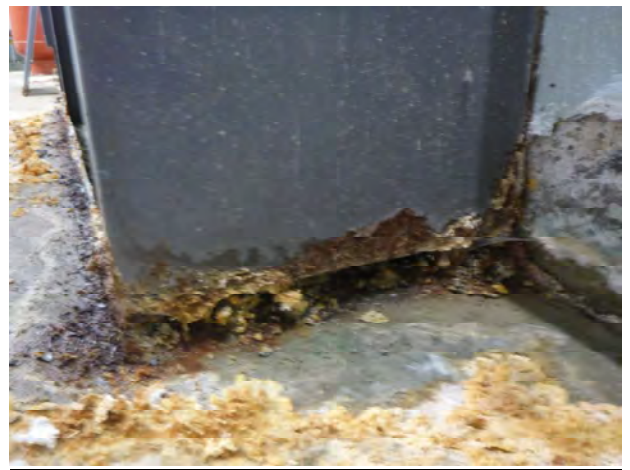
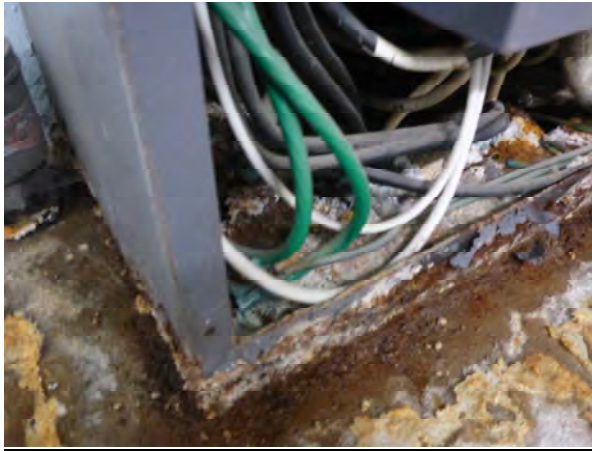
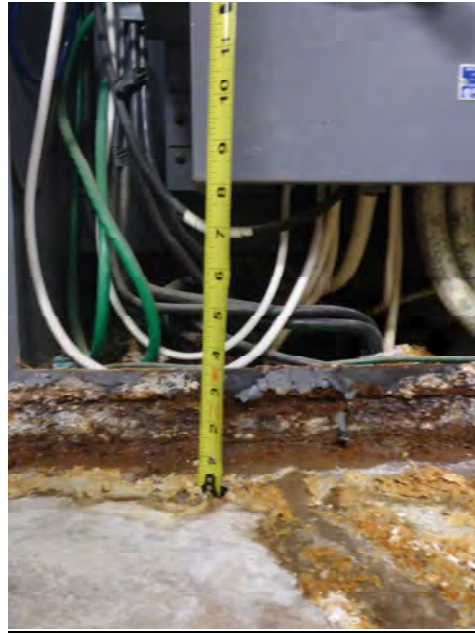
Indoor electrical distribution components are typically designed for a life cycle of 30 to 40 years under normal operating conditions. Exposures to water damage and regular preventative maintenance programs have significant influence on the reduction or extension of expected life cycle. Periodic changes in code requirements and technological innovations lead to new system designs resulting in older equipment eventually becoming obsolete. Serviceability of older systems is compromised by the limited availability of obsolete parts and lack of service personnel trained to maintain older systems. The estimated year of installation of the distribution board is 1962 and is well beyond its expected life cycle.

It has been determined that the distribution board has sustained a large amount of damage from sustained contact with water on multiple occasions. The base of the distribution enclosure shows significant rusting and deterioration. The current location of the distribution board is clearly inappropriate for safe operation of electrical equipment. Should water enter the mechanical room again in the future and reach a level in which it comes in contact with the electrical bussing a short circuit or dangerous fault condition could result and significant damage could occur.

The study determined the existing main distribution board is in very poor condition and should be replaced. Consideration should be given to relocating the distribution board to a location above grade where it is protected from contact with water and flooding.
